Storm Damage Report

Memorial Inn & Suites
9535 Katy Freeway
Houston, Texas 77024

FIELD REPORT FOR INITIAL STORM DAMAGE INVESTIGATION

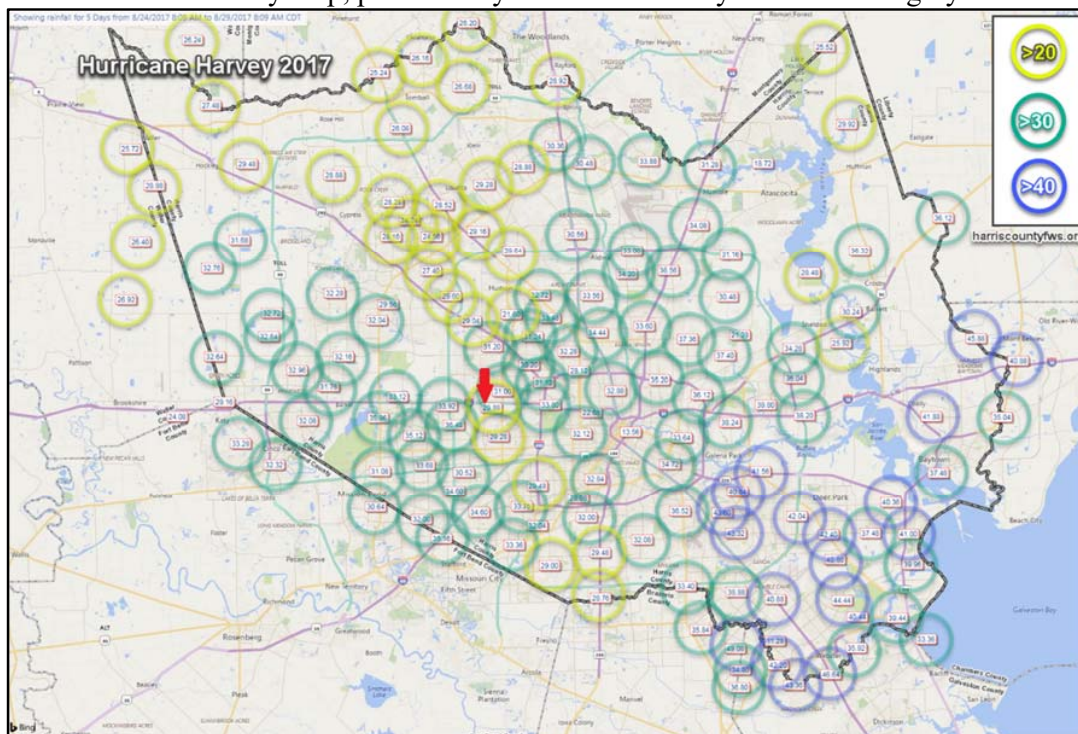
Red arrow is placed at location of the Memorial Inn. Map indicates approximately 30" of rain fell in the vicinity between August 24 and 29, 2017.

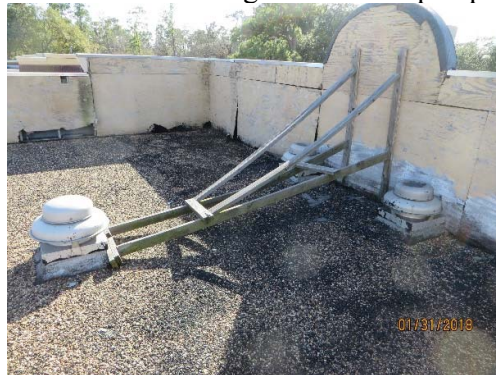
Figure 7

- 2" x 4" non-conventional wood bracing used for tall parapets.

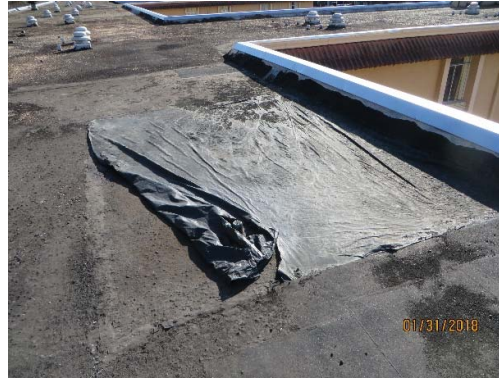
Figure 10

- Roof areas where an additional flood coat was applied
- A temporary repair with a black tarp observed between the first and second wings.
